Highbarns Chalk Mines Project

Cavity Auto Scanning Laser System (C-ALS) Survey Report

Report No	0005-UA000857-GDR-01-0	
Date	28 June 2011

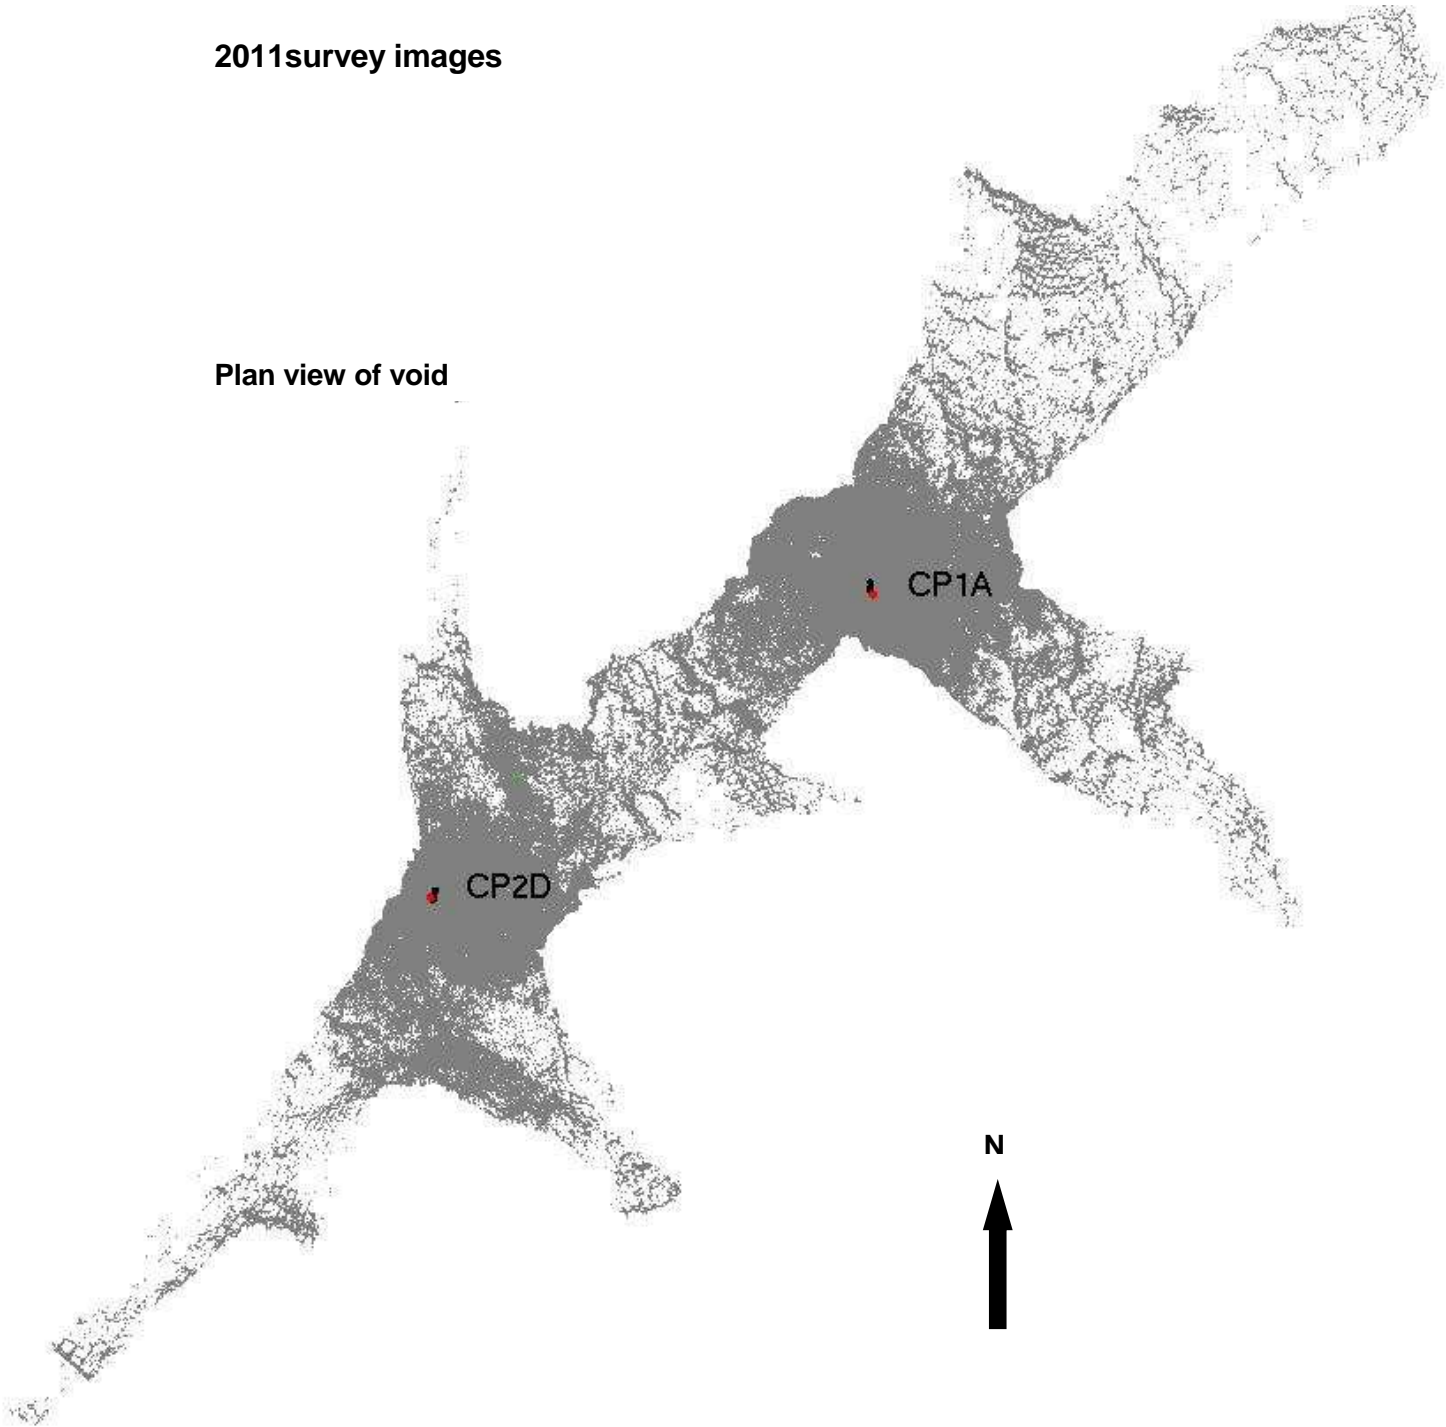
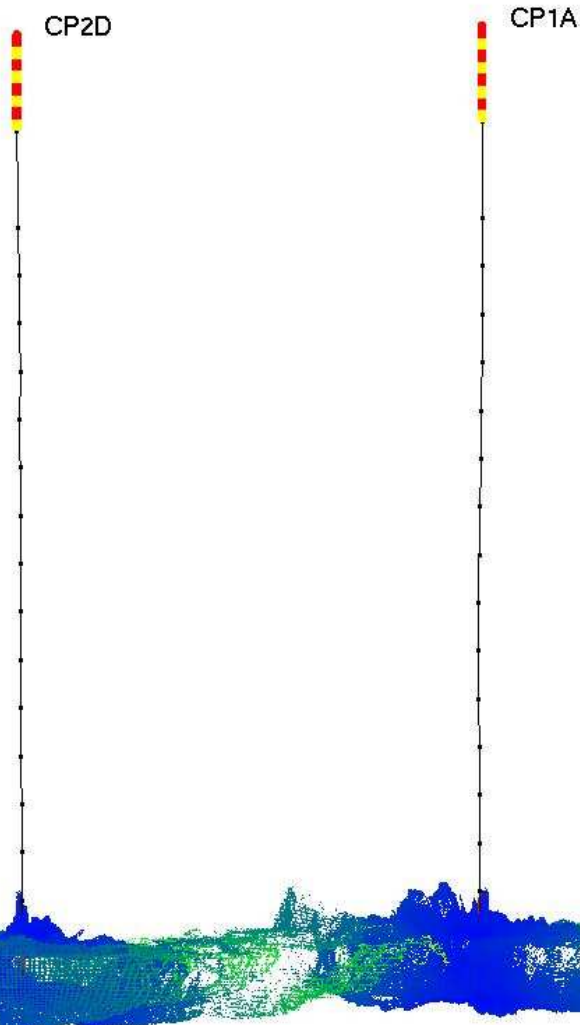
Plan view of void

**Mine workings laser survey image
as viewed looking East**

Mine workings laser survey image including bore track as viewed looking North

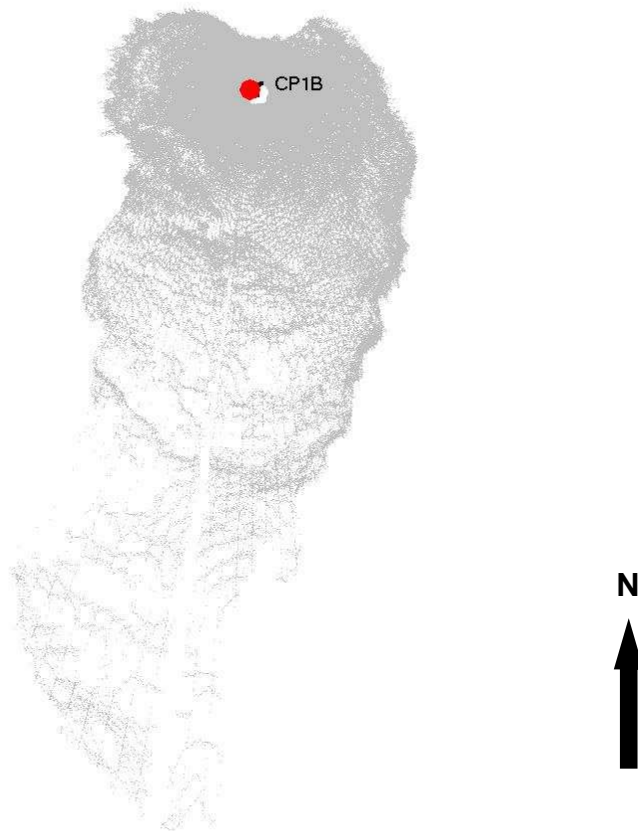
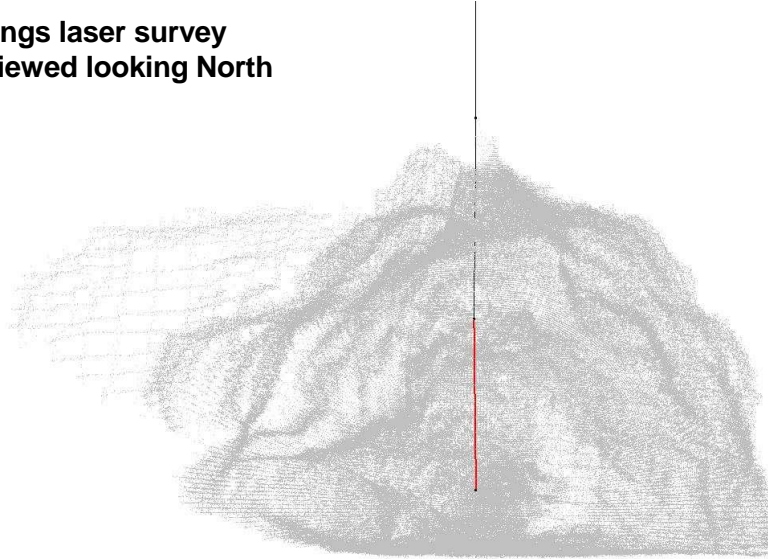
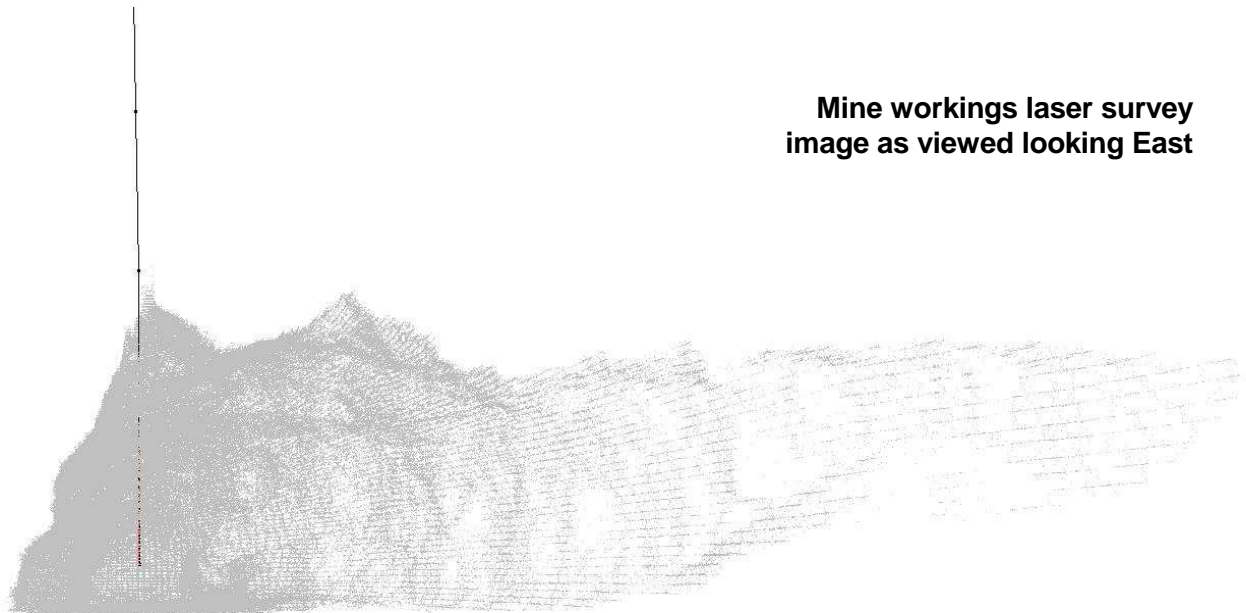
Plan view of void

**Mine workings laser survey
image as viewed looking North**

**Mine workings laser survey
image as viewed looking East**

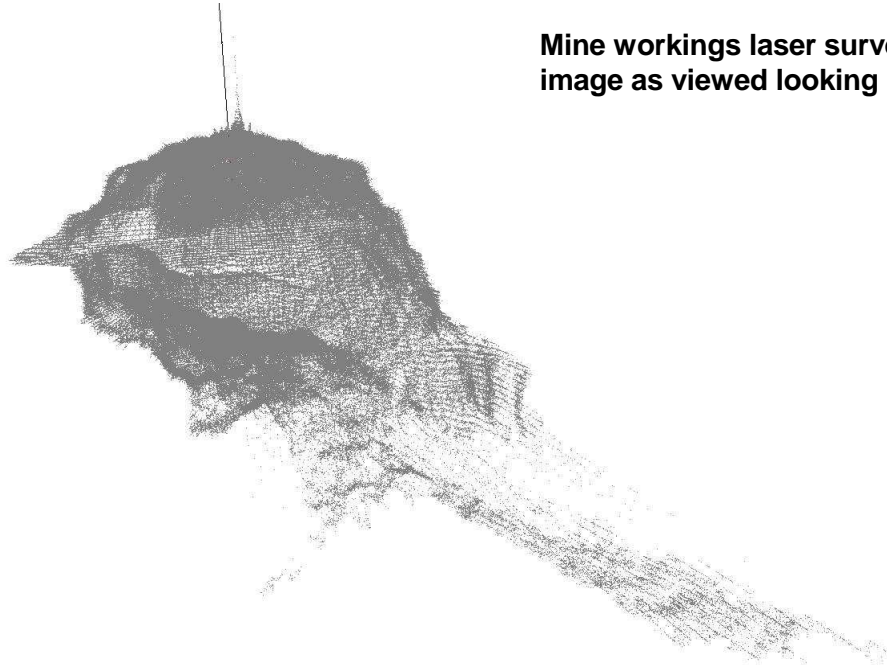
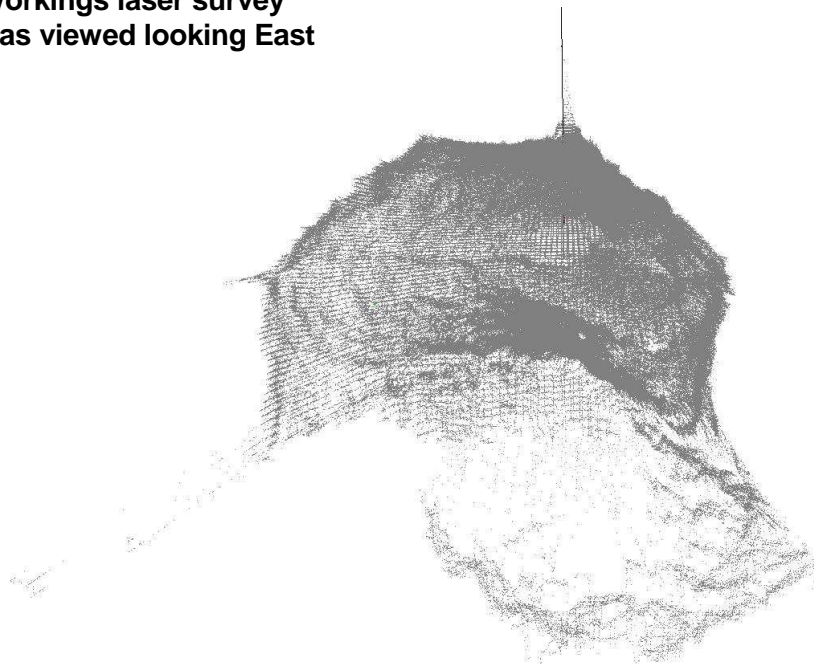
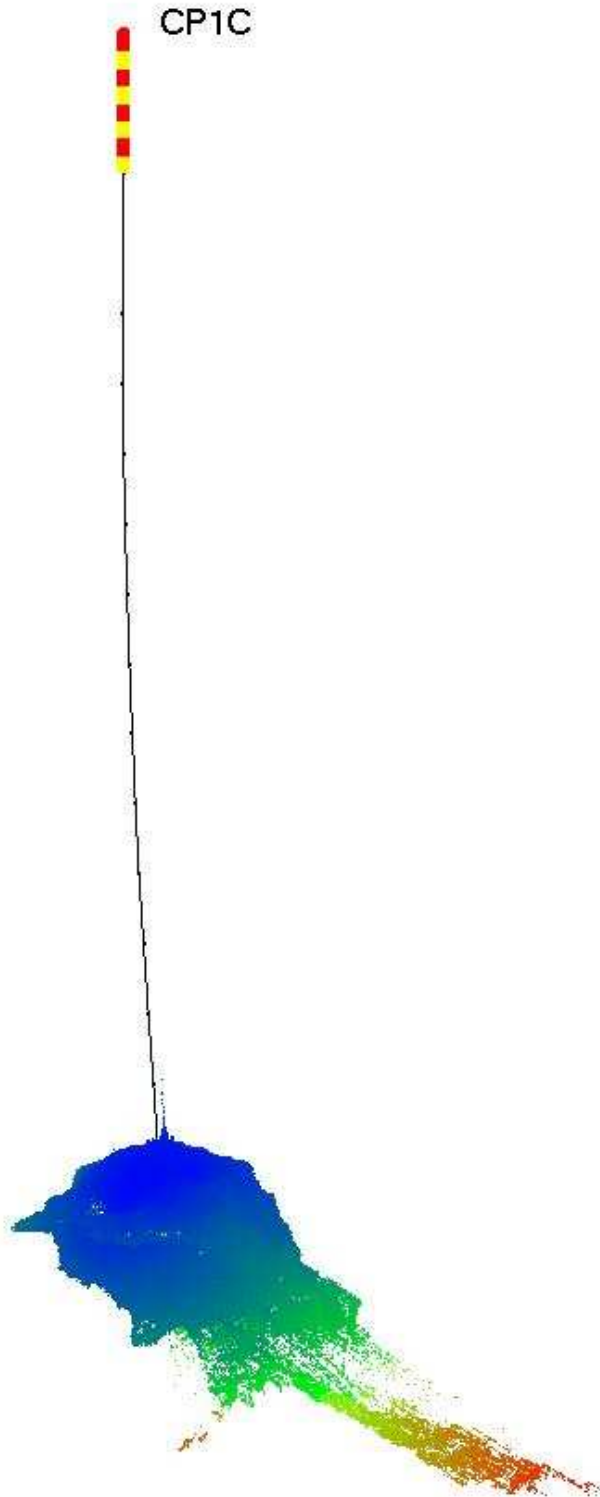
2011 survey images

**Mine workings laser survey
image as viewed looking North**

**Mine workings laser survey
image as viewed looking East**

**Mine workings laser survey
image including bore track
as viewed looking North**

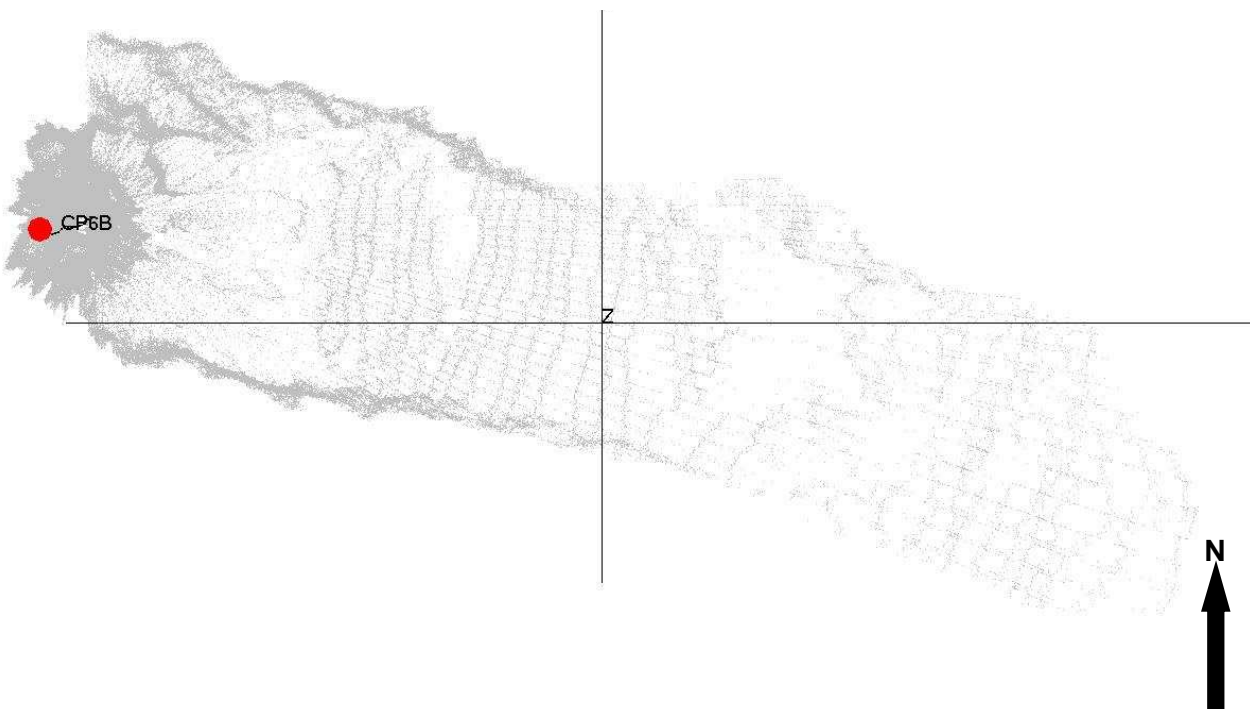
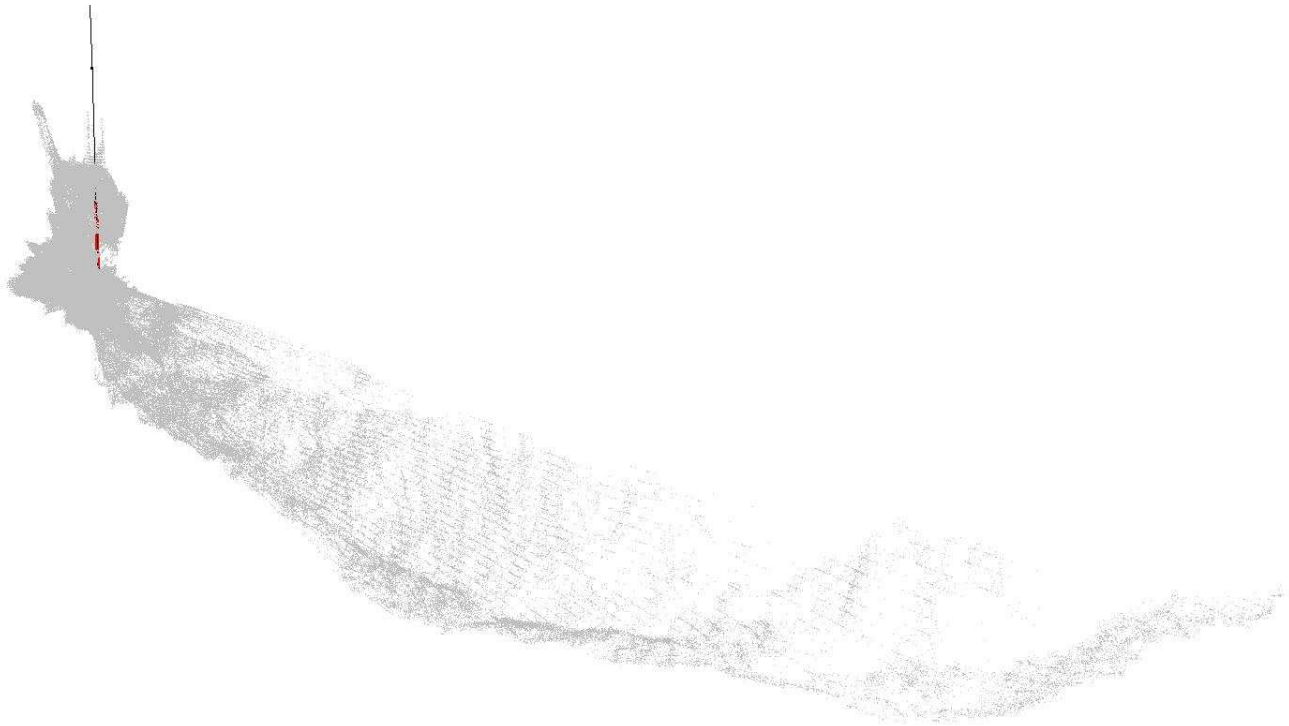
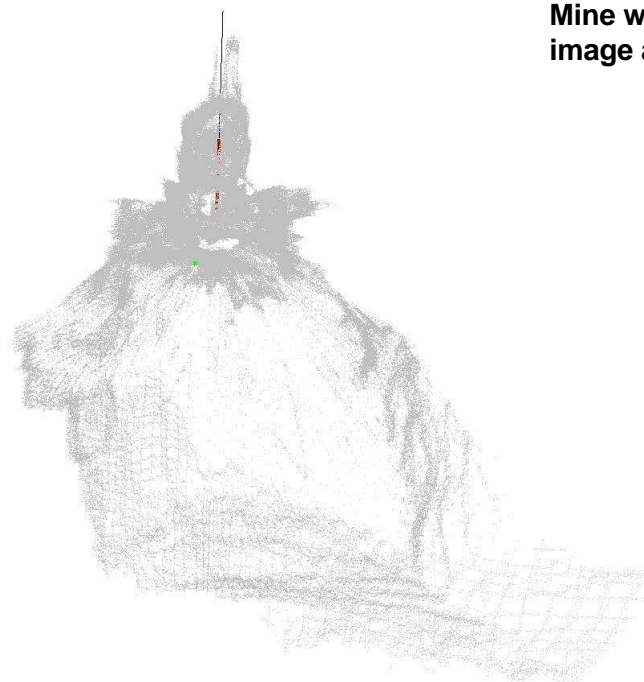
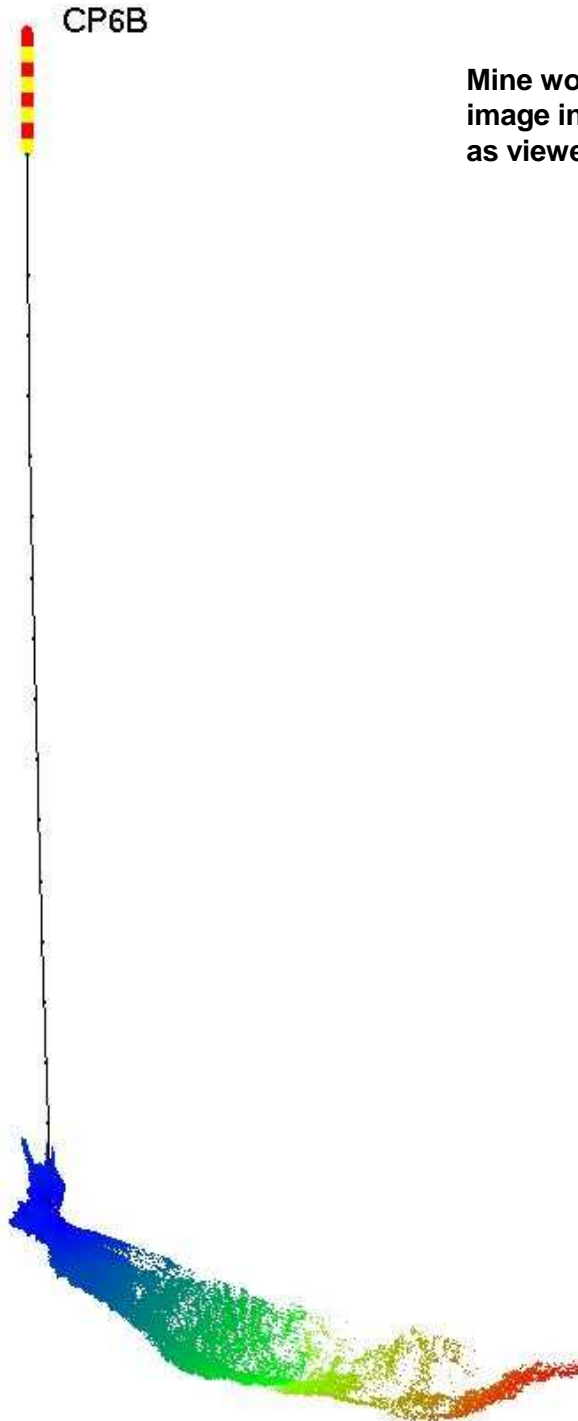
Plan view of void

**Mine workings laser survey
image as viewed looking East**

**Mine workings laser survey
image including bore track
as viewed looking North**
