CHALK MINE STABILISATION PROJECT HIGHBARNS, HEMEL HEMPSTEAD

Treatment Report

Report No 00013-UA000857-TR-01

DECEMBER 2015

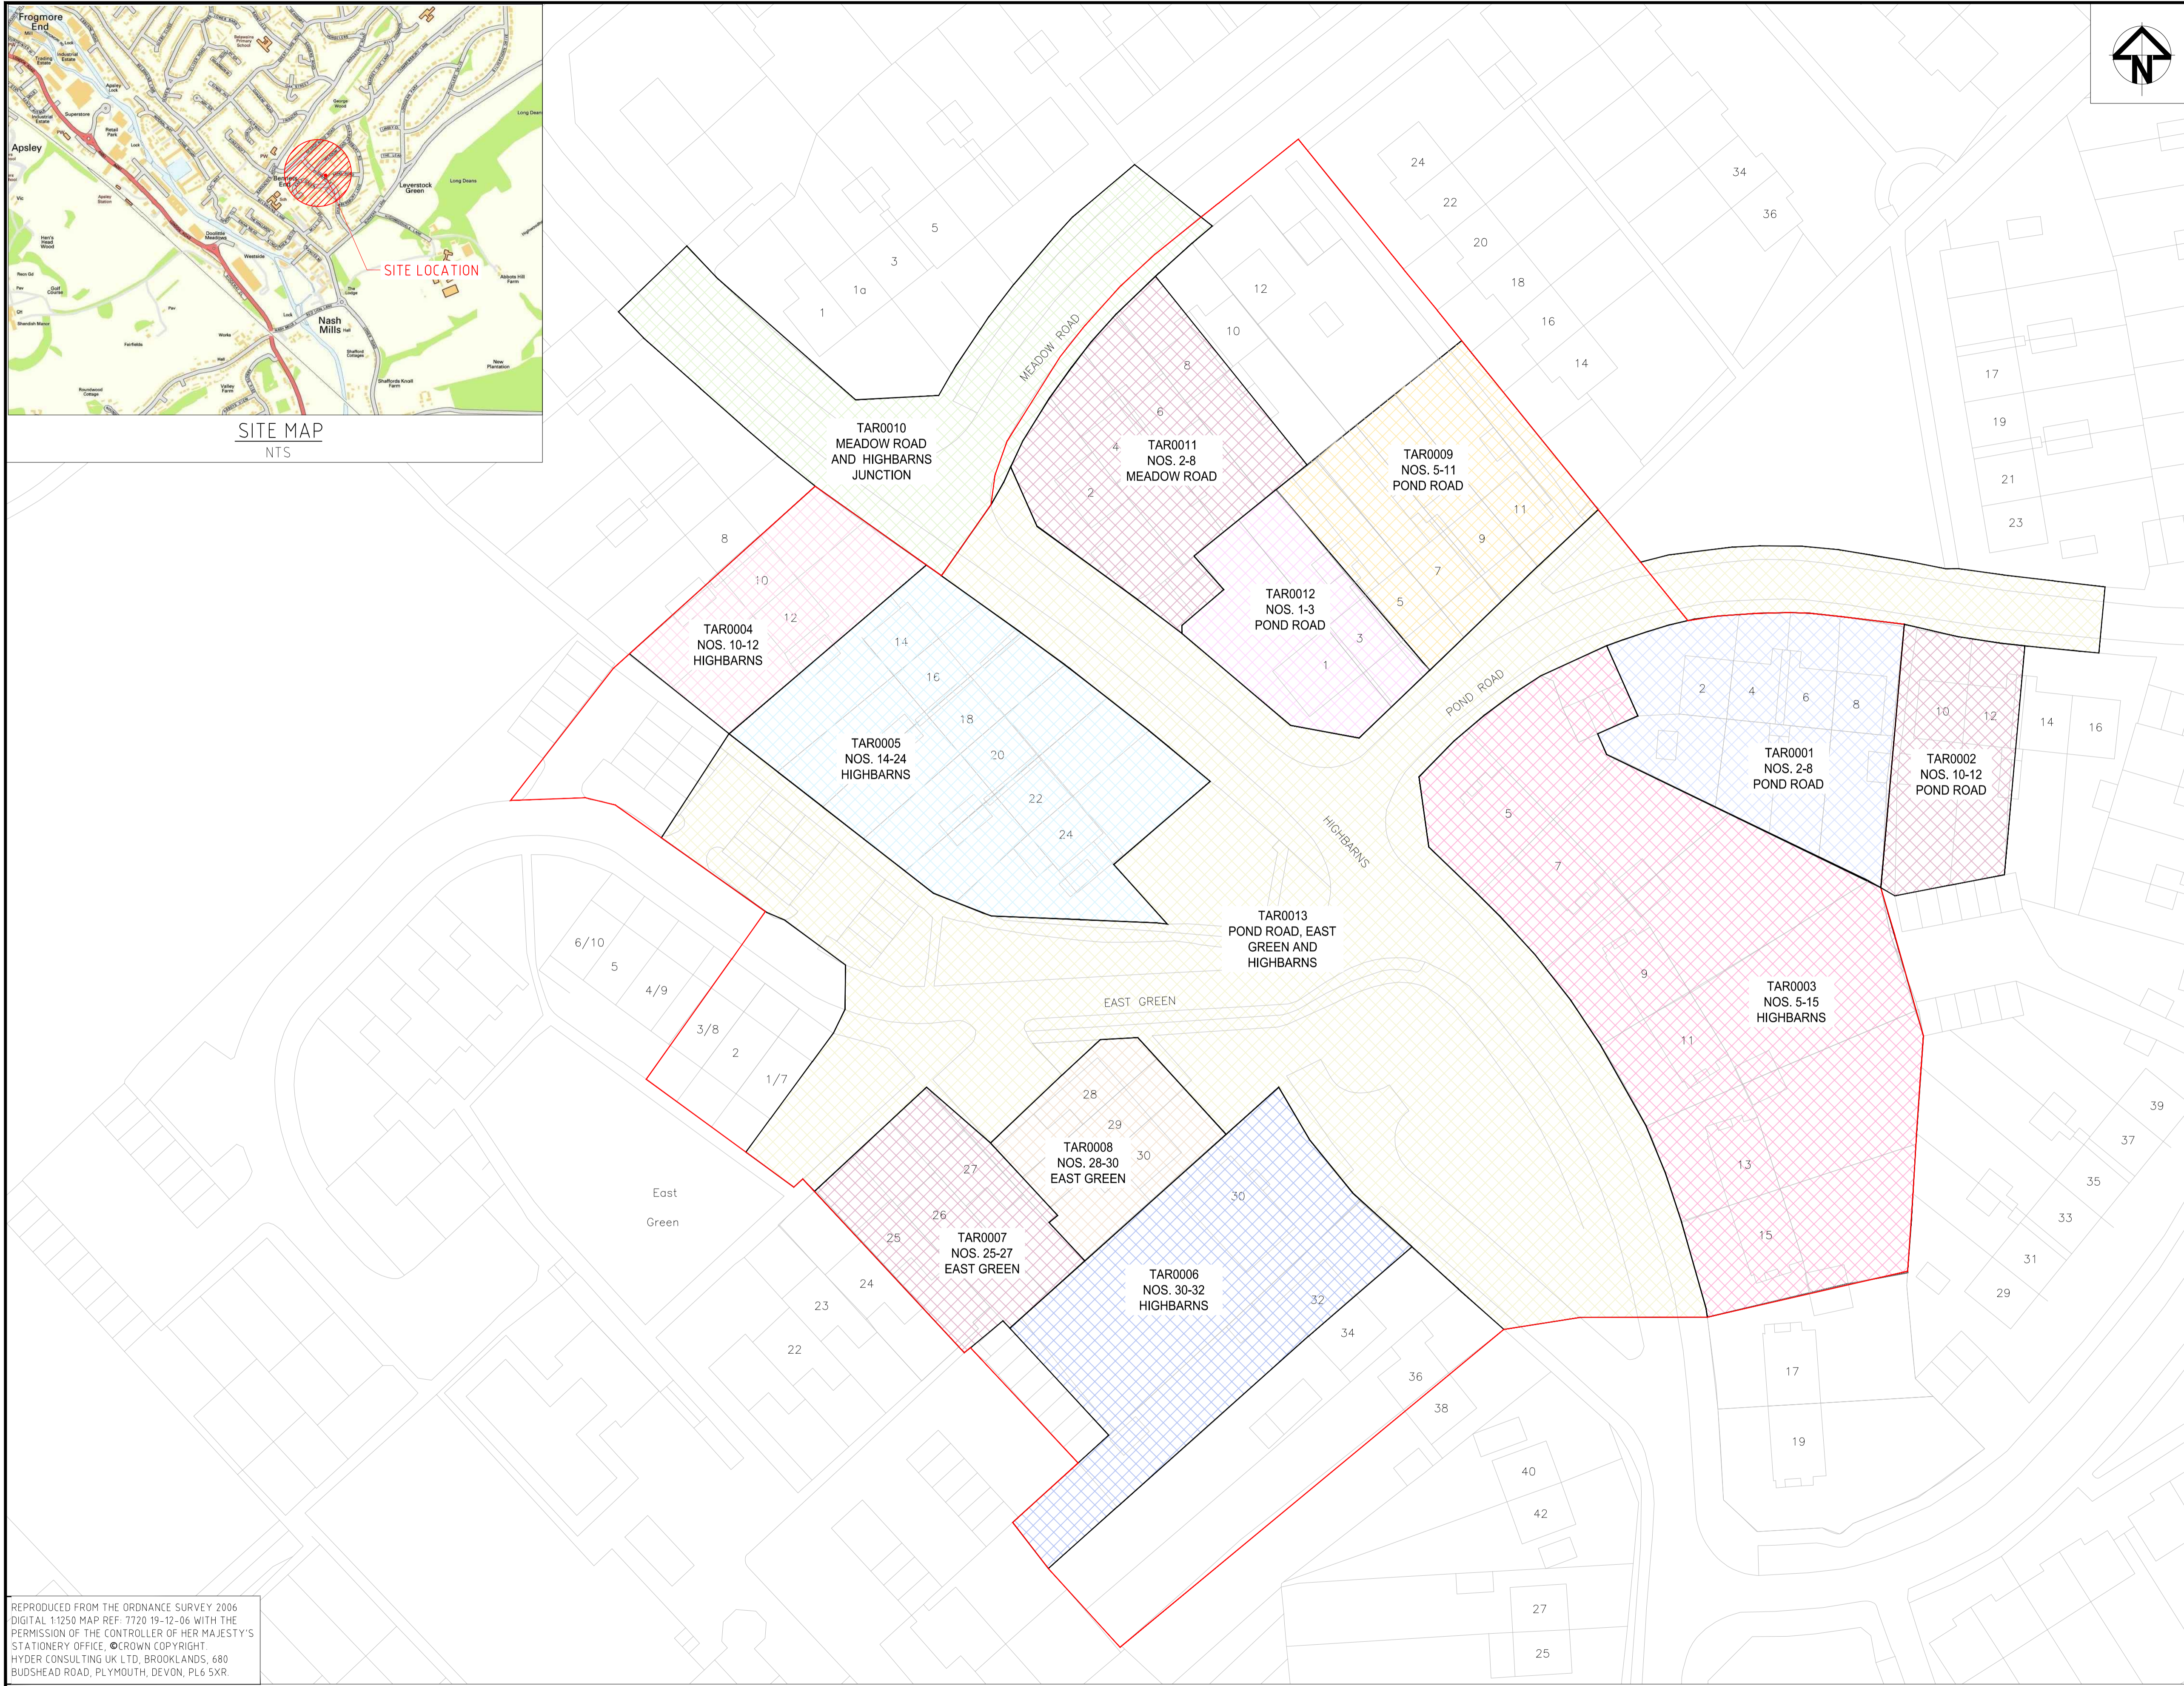
TREATMENT AREA PLAN
SCALE 1:400

During the ground investigation, extensive super heavy dynamic probing (DP) was undertaken to identify voids and collapsed ground. A close correlation was found between DP blow values of less than 3 per 100mm penetration and the presence of workings. It was concluded that comparison between pre and post treatment dynamic probe holes would allow an objective assessment of the effectiveness of the treatment. Blow counts greater than 3 per 100mm were determined to represent an acceptably treated mine, based on the results of the pre-treatment surveys. To allow manageable assessment of the data the site was divided into 14 No. discrete treatment areas (see Figure 2).

A summary for each Treatment Area (numbered TA001 to TA0014) is presented in Figure 2, Appendix A adopting the numbering system of the contractor's Sectional Validation Reports, which were numbered VR01 to VR010 (see Appendix E).

- Treatment Area 1: Nos. 2-8 Pond Road
- Treatment Area 2: Nos. 10-14 Pond Road
- Treatment Area 3: Nos 5-15 Highbarns
- Treatment Area 4: Nos. 8-12 Highbarns
- Treatment Area 5: Nos. 14-24 Highbarns
- Treatment Area 6: Nos. 30-34 Highbarns
- Treatment Area 7: Nos. 25-27 East Green
- Treatment Area 8: Nos. 28-30 East Green
- Treatment Area 9: Nos. 5-11 Pond Road
- Treatment Area 10: Meadow Road and Highbarns Junction
- Treatment Area 11: Nos. 2-8 Meadow Road
- Treatment Area 12: Nos. 1-3 Pond Road
- Treatment Area 13: Pond, Highbarns and East Green Roads

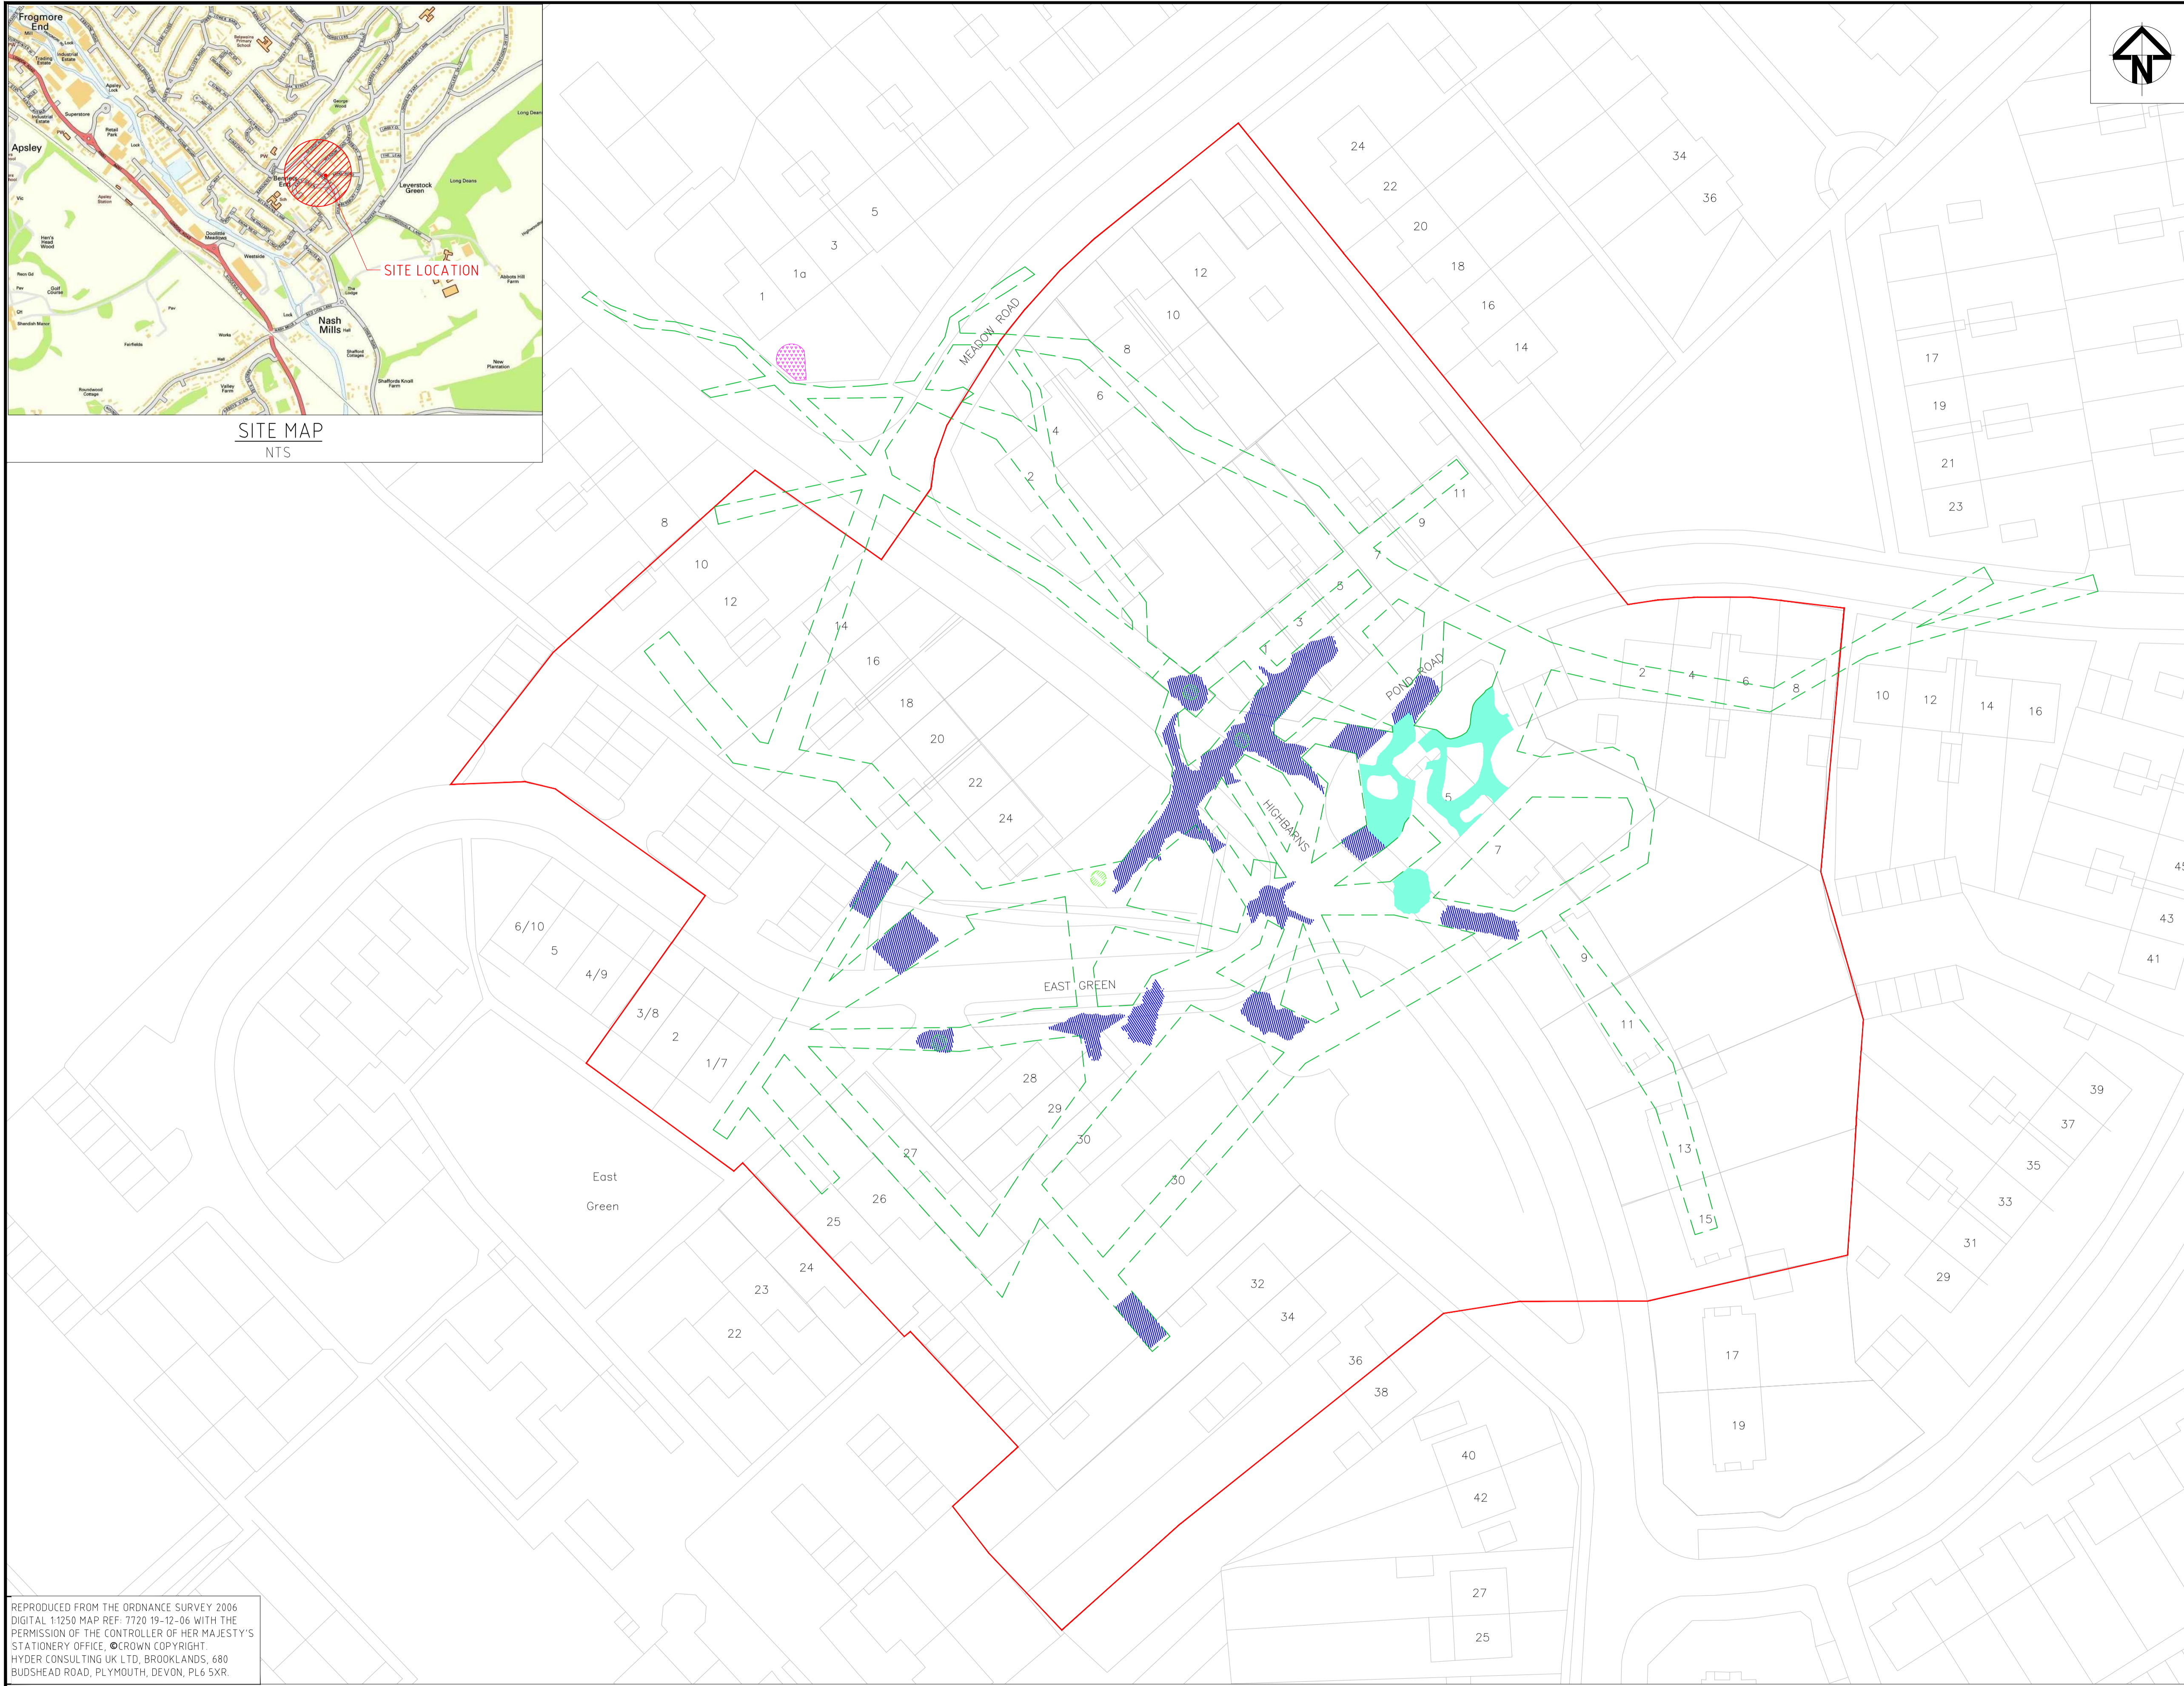
Drawing GDD-022-UA4004620: Interpreted Mine Layout

The extent of the mine workings at the site, as determined following the pre-treatment ground investigations, has been reviewed in the light of the additional information gained during the mine stabilisation works. This information has been derived from the following sources;

The interpreted mine layout, along with a summary of grout takes and recorded areas of voids and disturbed ground are also shown in the Arcadis individual treatment area reports contained in Appendix B. Whilst the method of boring grout holes (open hole auguring) allowed only basic logging of the soils encountered this was sufficient to allow disturbed ground and voids to be recorded. In addition, it was possible to identify grout in the drilling arisings in areas where treatment had previously been carried out adjacent.

The revised mine layout is shown in Figure 3, Appendix A.
