# CHALK MINE STABILISATION PROJECT HIGHBARNES, HEMEL HEMPSTEAD

Treatment Area 13: Highbarnes, East Green and Pond Road

Report Number: 0013-UA000857-TR-01-TAR-0013

OCTOBER 2015

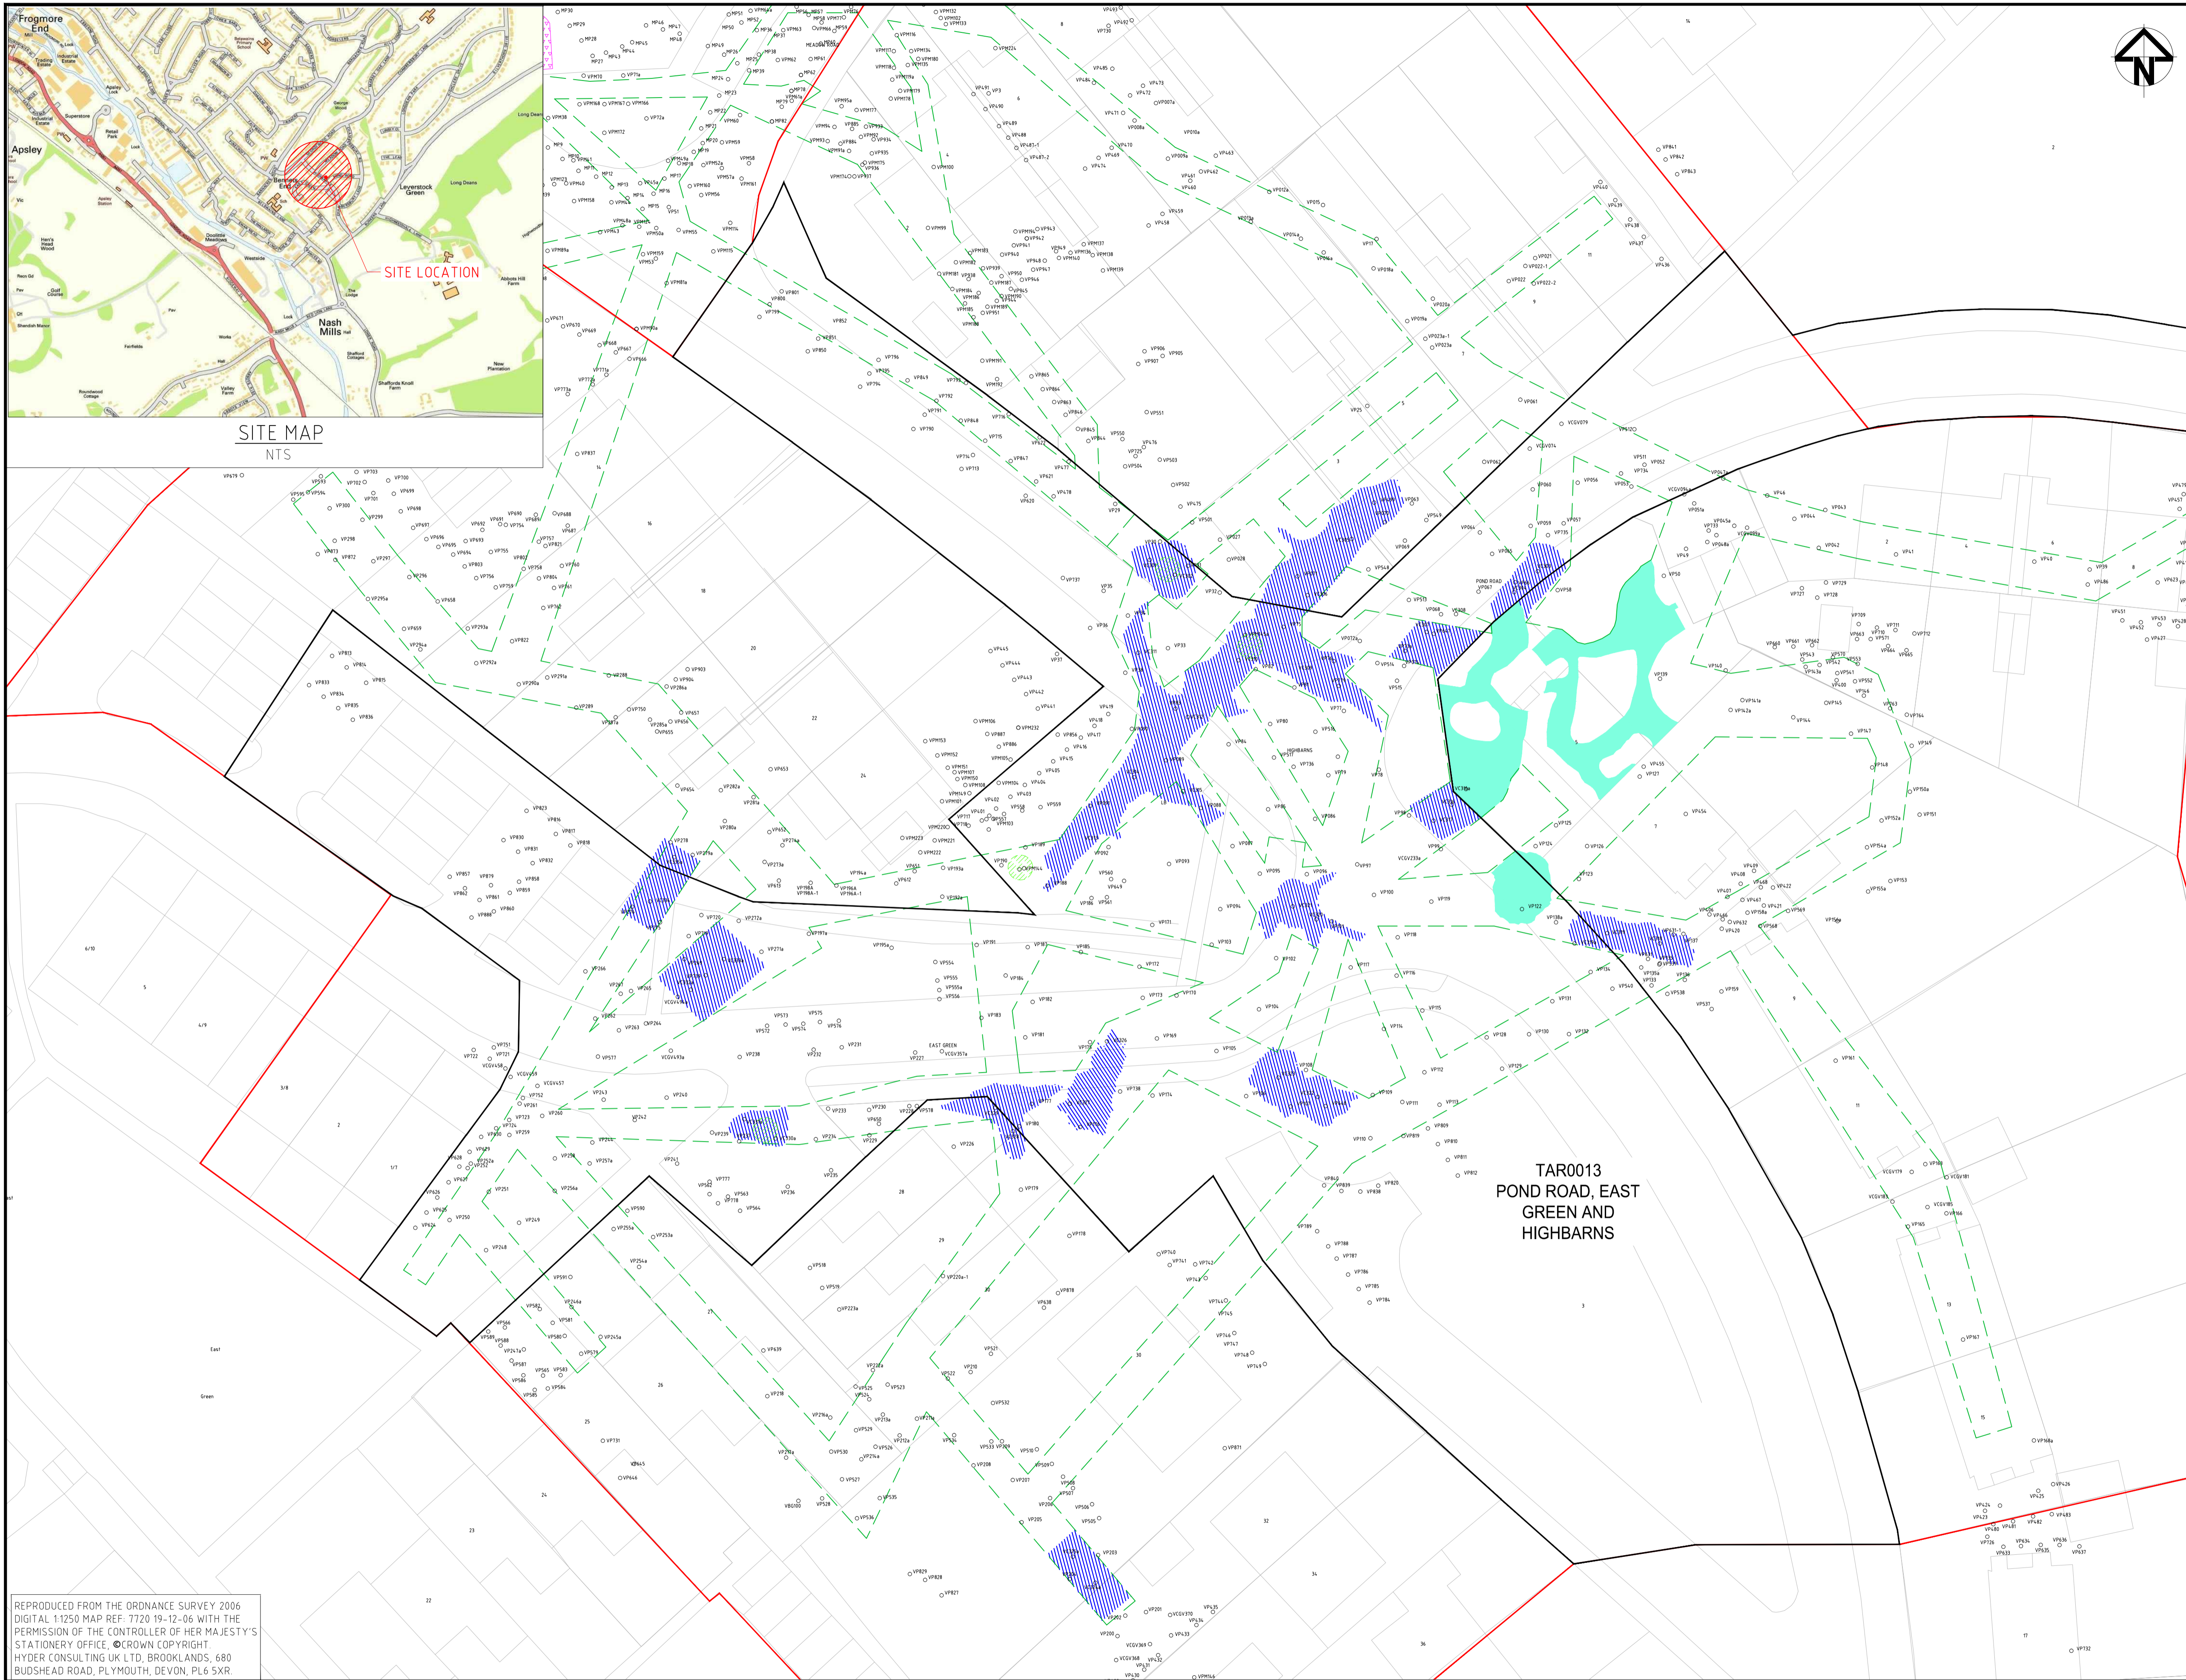
Drawing title:  
TREATMENT AREA PLAN  
FOR TAR0013  
WITH GROUT HOLES

Treatment along the main roadways at Highbarns, East Green and Pond Road located within the Derelict Land Clearance Order (DLCO) boundary confirmed the expected location of four shafts assessed from the pre-contract investigations. Two shafts have been treated adjacent to No. 1 Pond Road. A third shaft was located beneath an area of public open space adjacent to No. 24 Highbarns and a fourth shaft within an open space along East Green. The locations of several areas of open mine workings identified during laser scanning surveys that have been bulk filled are shown on Drawing TA0013-01 presented in Appendix A.

Initial treatment at the road junction involved bulk infilling of the extensive open mine gallery uncovered across Highbarns. High grout volumes were recorded at BG005 (113.0m<sup>3</sup>), BG006 (84.5m<sup>3</sup>) and BG008 (117m<sup>3</sup>) confirming the interpreted mining extents. Further bulk infilling was carried out along the open mine workings south of the main voided area and a combined grout volume of 80.0m<sup>3</sup> at locations BG017 and BG018 confirmed the voided nature of the mine. During ongoing treatment works at BG017, grout was observed emerging from the adjacent grout hole BG018 which confirmed the extent of treatment of open mined ground at this location.

Following an initial phase of bulk infilling at known open mine workings, compaction grouting was undertaken along the interpreted mine galleries treating areas of collapsed ground. Subsequent compaction grouting close to a previous bulk infill location (BG008) resulted in a high grout volume at CGV217A (20.7m<sup>3</sup>) indicative of residual weak ground probably associated with the adjacent shaft location. Similarly consistent high volumes were observed closer to the central mine junction. Initial bulk infilling at BG011 (36.0m<sup>3</sup>) was followed by high volumes at compaction grout holes CGV250 (18.8m<sup>3</sup>) and CGV220 (35.1m<sup>3</sup>). This suggested incomplete treatment during the initial grouting phase probably due to the collapsed nature of the mine. This was confirmed by low blow counts in pre-contract validation probes VP077 and VP081. Additional grouting at CGV610 (12.0m<sup>3</sup>), CGV611A (11.4m<sup>3</sup>) and CGV612 (14.9m<sup>3</sup>) was carried out to re-treat the area with the resultant volumes confirming the necessity of further treatment. A final phase of validation dynamic probing (particularly VP516 and VP736) identified improved ground conditions which were not suggestive of residual untreated mines. Similarly, CGV260 (10.2m<sup>3</sup>) and CGV262 (21.4m<sup>3</sup>) located either side of open mine working (BG017 and BG018) at the central junction suggested further extension of the mine workings both north and south along Highbarns.

High grout volumes were also observed in areas away from open mine workings. Adjacent high volumes at CGV246 (13.5m<sup>3</sup>), CGV242 (29.4m<sup>3</sup>), CGV239 (12.2m<sup>3</sup>) and CGV237 (25.4m<sup>3</sup>) suggested more collapsed mine workings extending towards the centre of the road junction. Similarly high grout volumes at CGV209b (12.6m<sup>3</sup>), CGV210b (20.0m<sup>3</sup>), CGV233A (18.0m<sup>3</sup>) and CGV234a (10.9m<sup>3</sup>) close by were also

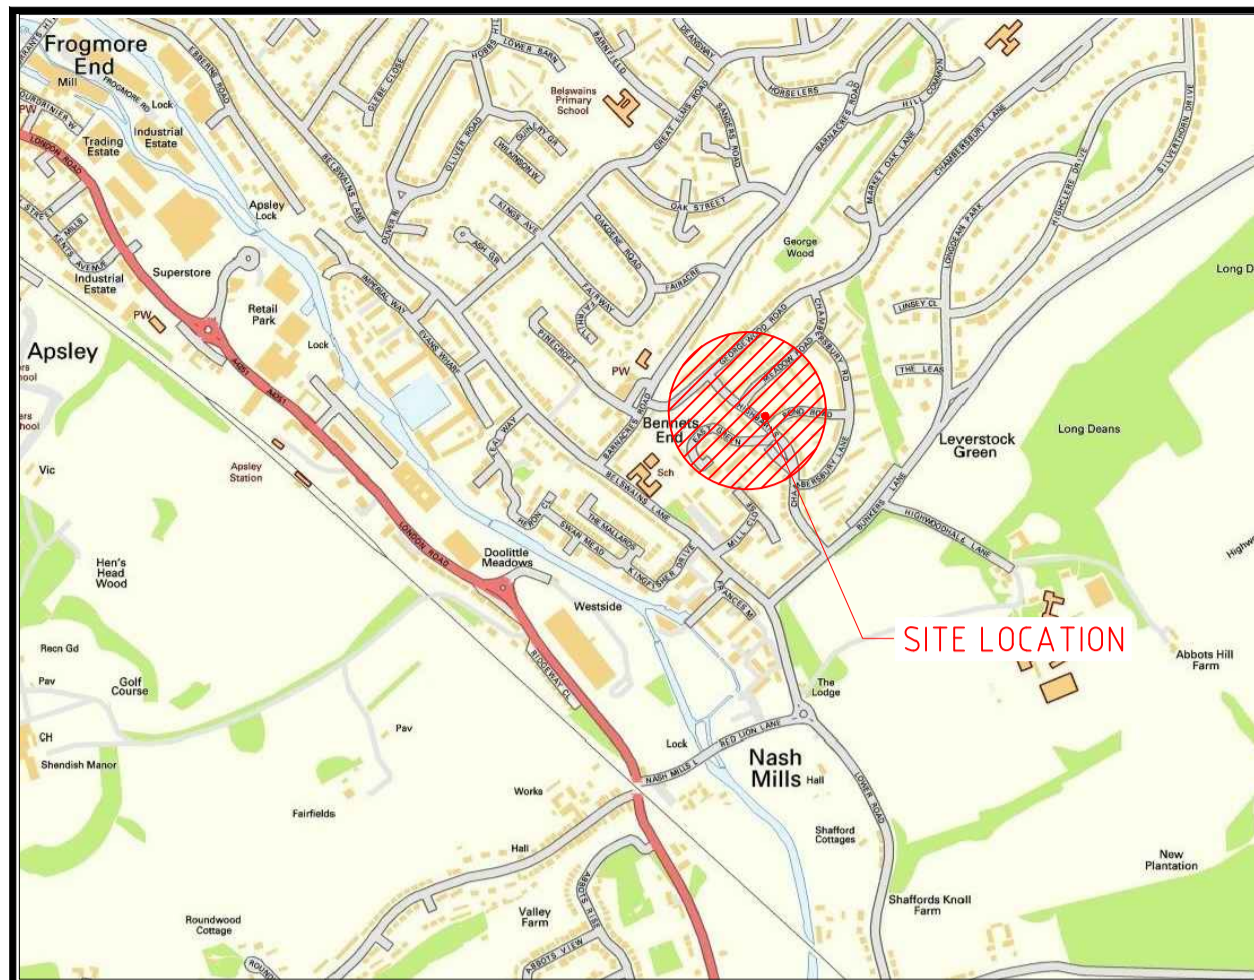
Drawing title: TREATMENT AREA PLAN  
FOR TAR0013  
WITH VALIDATION PROBES

Extensive validation dynamic probing was carried out following completion of the grouting works to confirm the termination of the assumed mine gallery extents. Additional dynamic probes VP560, VP561 and VP649 were carried out following high volumes at CGV254 (10.9m<sup>3</sup>) and CGV318 (14.0m<sup>3</sup>) suggested possible residual weakness towards the central road junction. The resultant dynamic probes did not uncover any evidence of untreated mined ground confirming the original mine layout. Validation probe VP119 in front of Nos. 5 and 7 Chantry Lane where high grout volume at CGV228 (25.4m<sup>3</sup>) was recorded did not reveal any residual untreated mining. An additional validation probe (VP779) was undertaken at the location of treatment works at CGV610 and CGV612. Results showed an improvement in ground conditions and did not indicate any residual untreated ground.

Two dynamic probes (VP477 – VP478) were initially carried outside the original mine extents. VP478 highlighted low blow counts at depth between 6.4m and 10.7m bgl which, while indicative of poor ground, was not considered sufficient evidence of further mine workings. A second row of dynamic probes (VP620-VP622) showed extensive evidence of low blow counts, particularly at VP620 and VP621, with a consistent mine depth between 14.0m and 18.0m below ground level.

Validation probing to investigate the extent of the mining was carried out following treatment works along East Green. Validation probes VP572 – VP576 failed to identify an additional mine gallery extending northwards while VP577 confirmed that there was no residual untreated ground at the suspected mine junction. Similarly, validation probes VP554 – VP556 confirmed no additional mine galleries extending eastwards along East Green.

Further investigation was undertaken in the grass verge in front of Nos. 25-27 East Green to identify potential mine galleries extending beneath the adjacent East Green Flats. The grout volumes in holes CGV466 (9.4m<sup>3</sup>) and CGV467 (8.0m<sup>3</sup>) were not suggestive of a larger extent of mine workings than previously interpreted. Successive rows of additional validation probes (VP624-VP630; VP721-VP724) did not suggest any evidence of weak ground extending beneath East Green Flats.
