CHALK MINE STABILISATION PROJECT HIGHBARNNS, HEMEL HEMPSTEAD

Treatment Area 3: Nos. 5, 7, 9, 11, 13 and 15 Highbarns

Report Number: 0013-UA000857-TR-01-TAR-0003

OCTOBER 2015

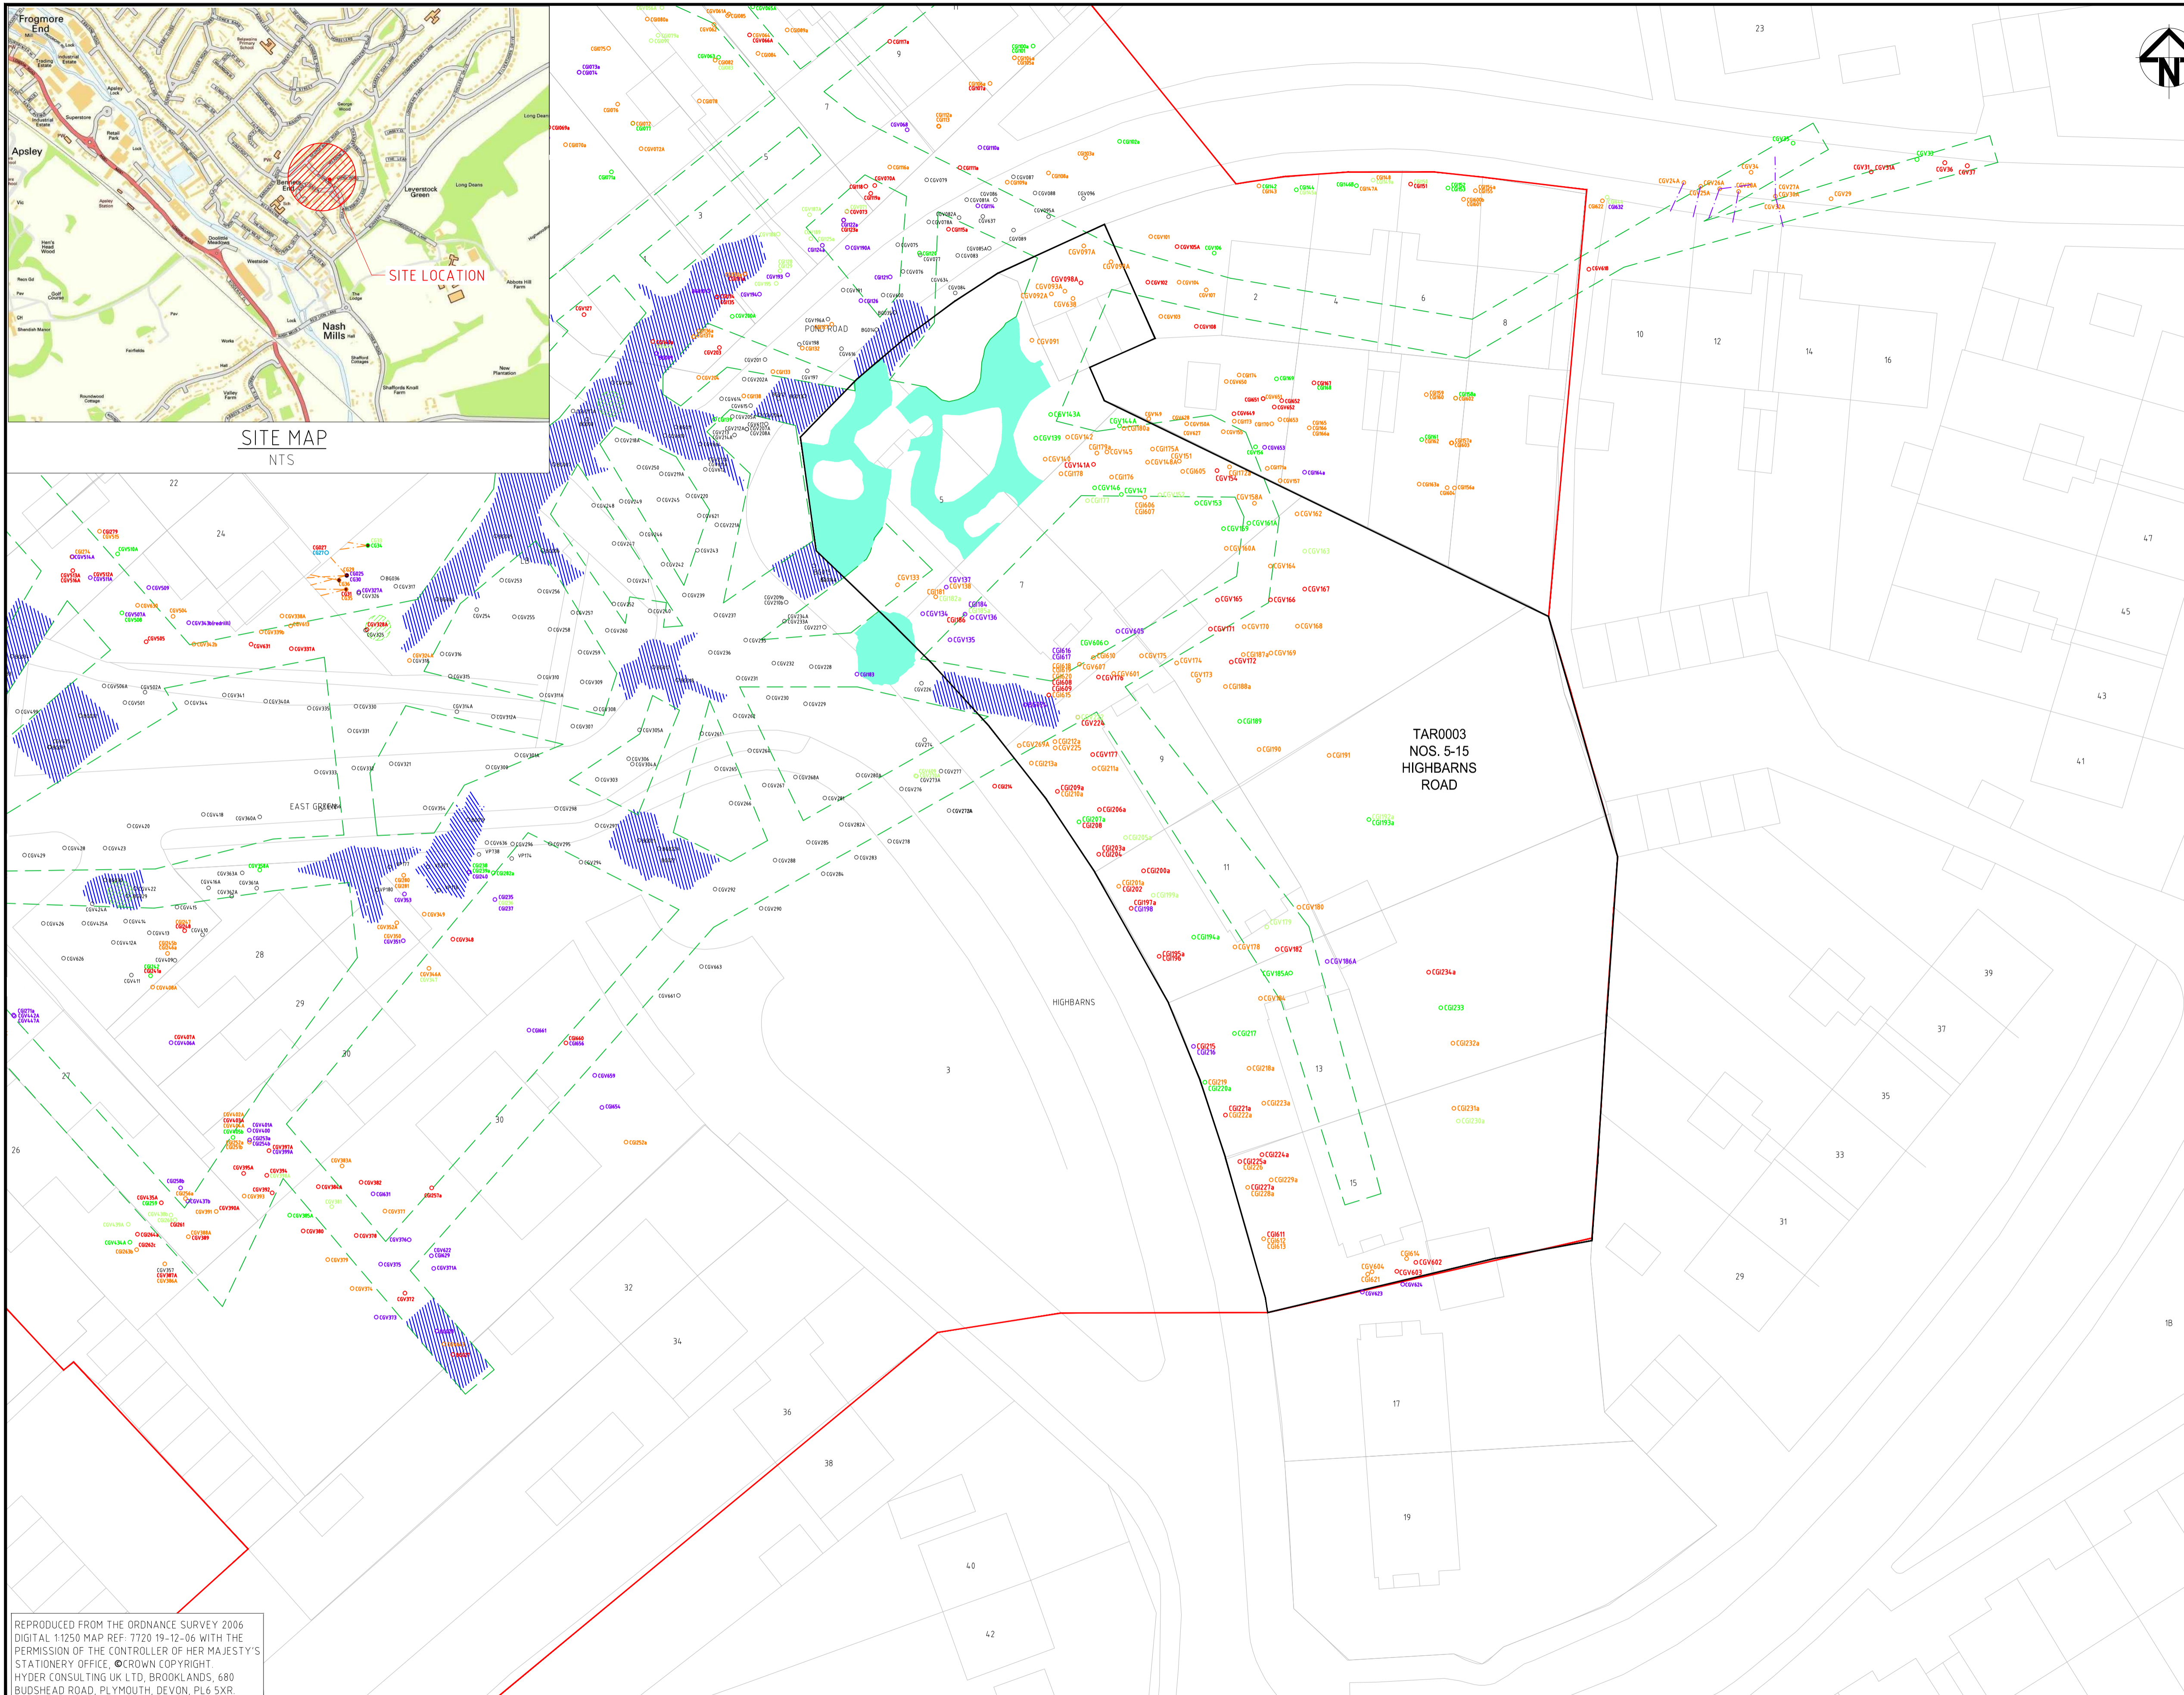
Drawing title: TREATMENT AREA PLAN FOR TAR0003 WITH GROUT HOLES

This Treatment area, validation probes and extent of grouting work specific to this treatment area are shown on Drawings TA0003-01 and 02 in Appendix A.

It was, however, considered prudent to undertake validation grouting around the property and a total grout volume of 33.875m³ was injected from twelve vertical holes located in the front and rear gardens of No. 5. Grout volumes ranged between 0.756m³ (indicating no weak ground) and an average maximum of approximately 4.0m³ (indicating possible untreated collapse mining) but the absence of any open mine workings.

Phase 1 grout treatment commenced in March and April 2013 with a cluster of grout holes located in the front garden of No. 7 Highbarns (CGV134-CGV137 and CGI181-CGI186) followed by grout treatment within the rear garden (CGV141A, CGV144-CGV148, CGV151-CGV154, CGV158-CGV161 and CGI175-CGI180) during the same phase of treatment. A grout volume of 55.326m³ was recorded in CGI184 indicating the presence of an open void which prompted a second phase of grout treatment beneath the south-eastern half of the building.

Grout treatment was predominantly undertaken as a single phase of work and consisted of a series of inclined and vertical grout holes across the property. Inclined grout holes (CGI203 to CGI214) located in the front garden recorded grout volumes ranging between 0.524m³ and 6.996m³ indicating treatment of mining disturbed ground. Similarly, inclined grout holes located in the rear garden to treat beneath the house recorded grout volumes of between 1.494m³ and 3.516m³.

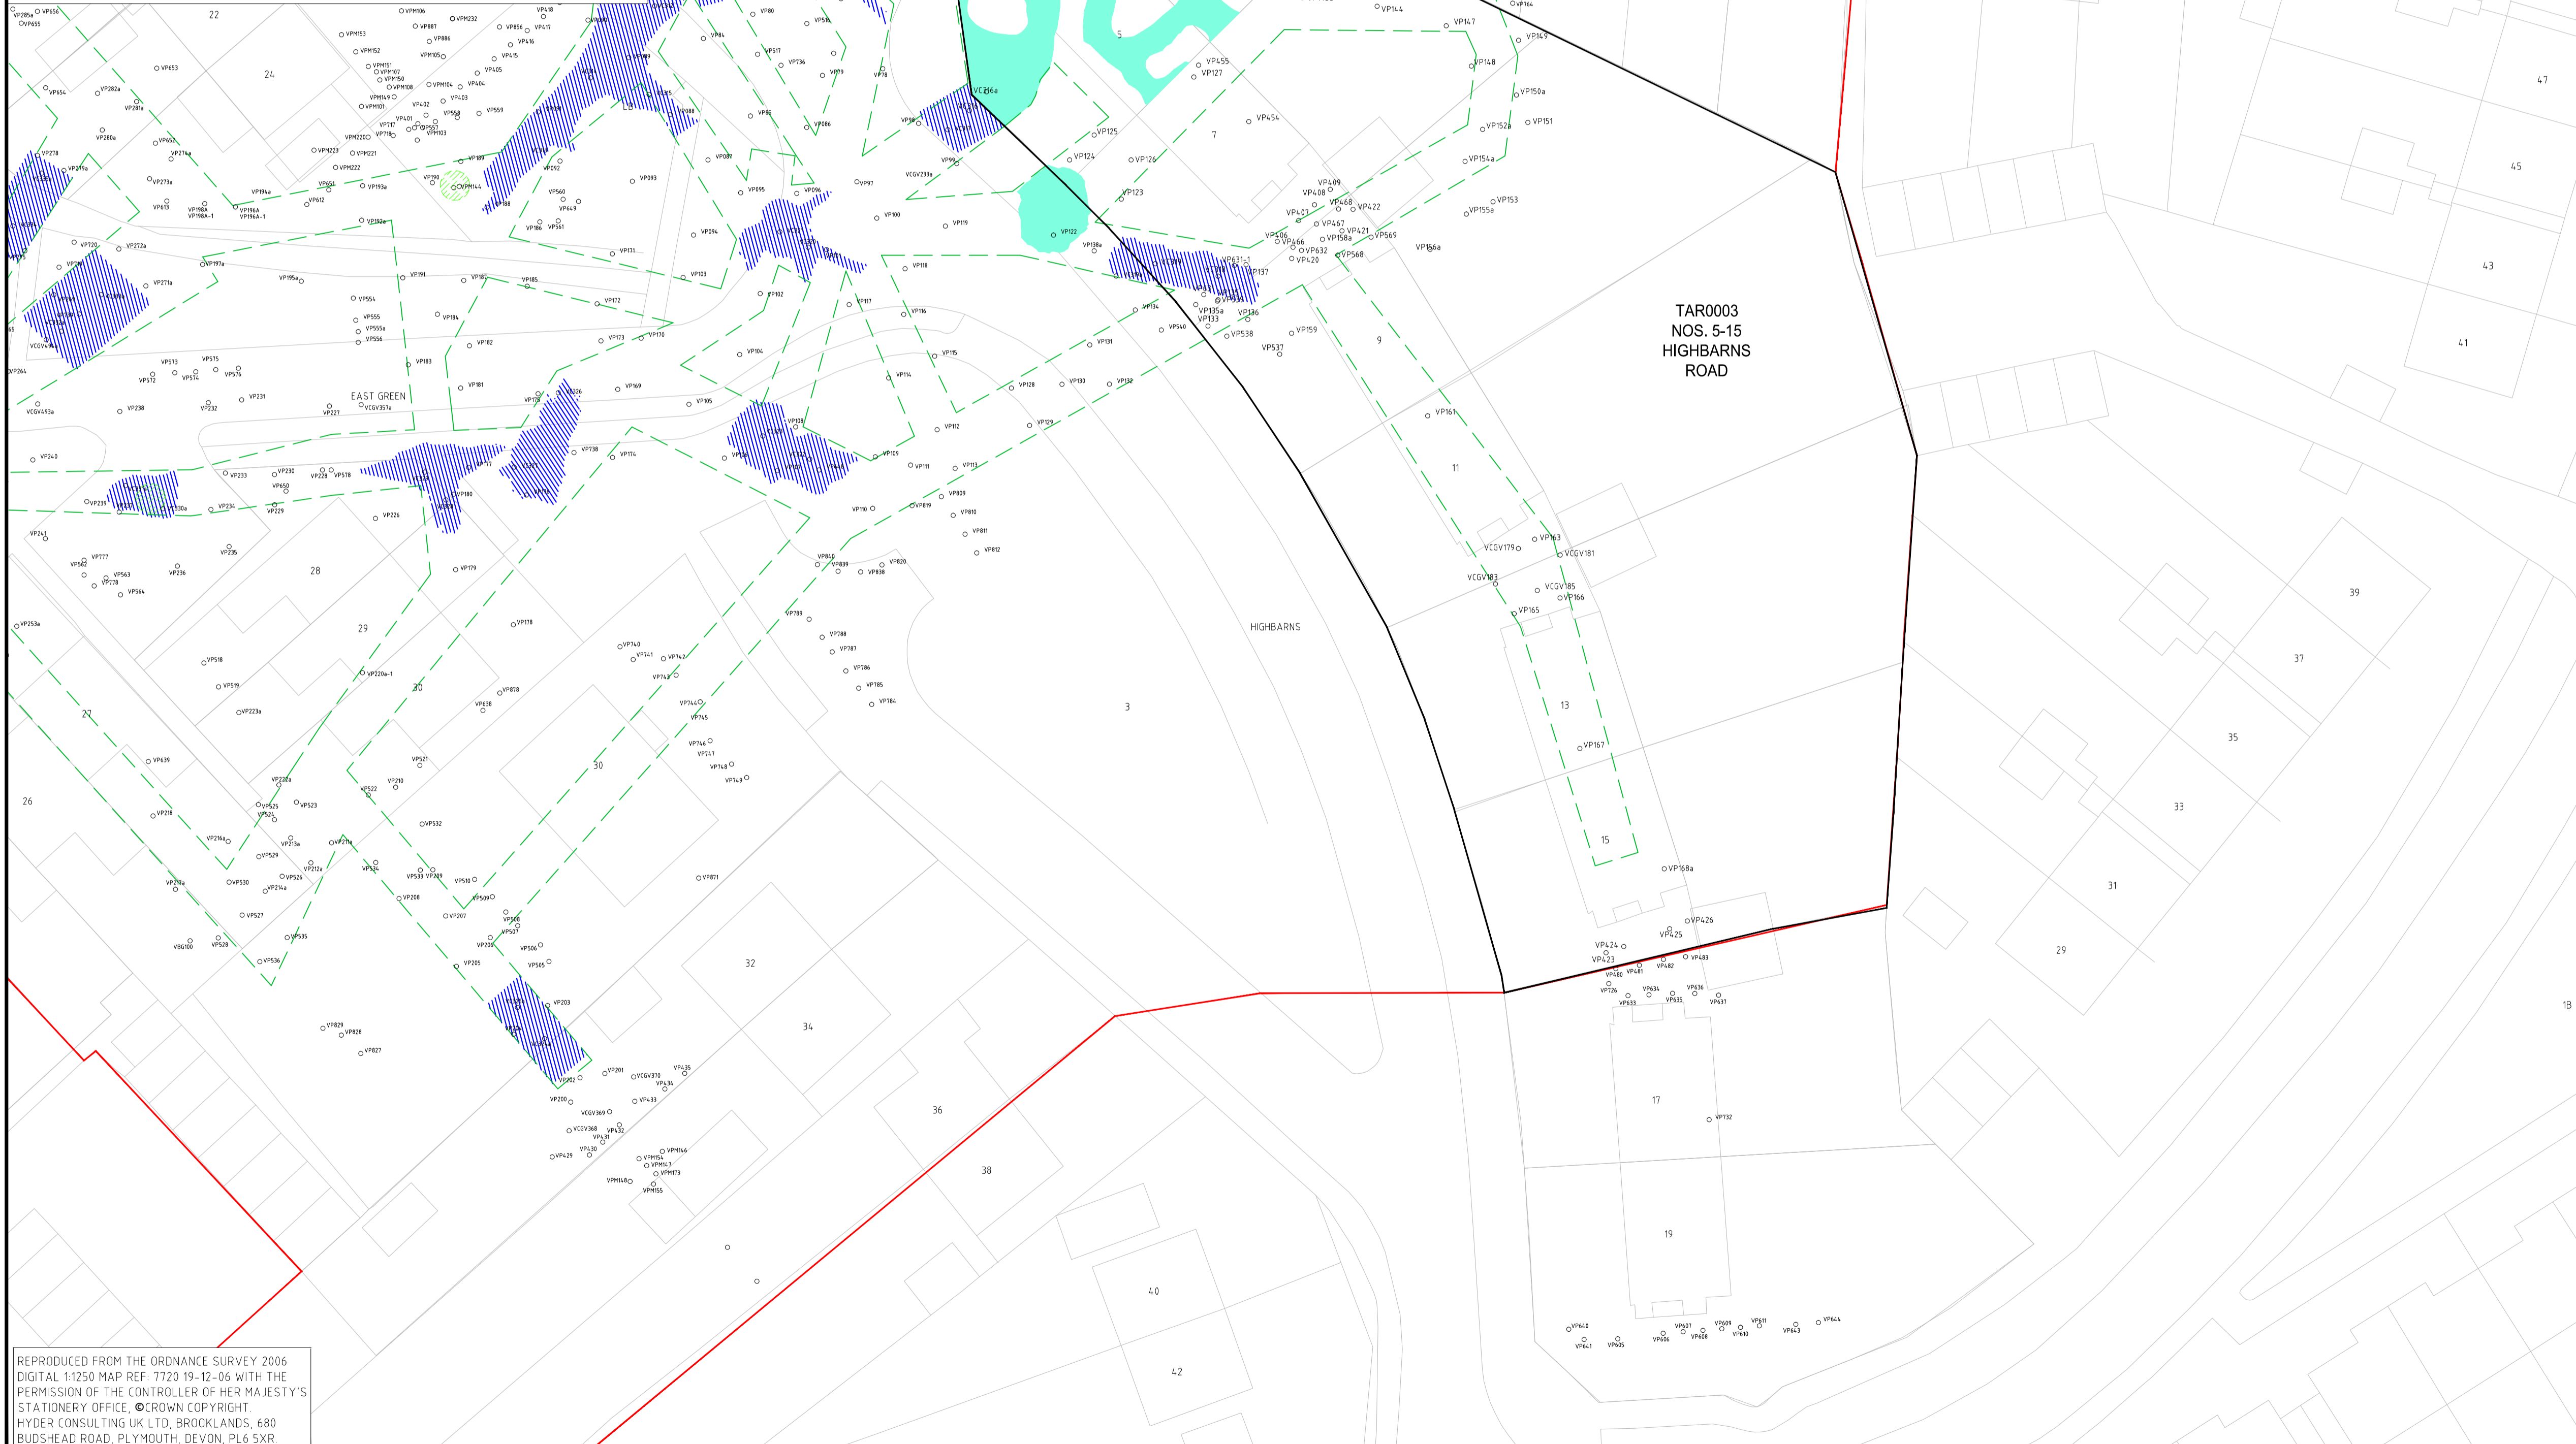
Drawing title: TREATMENT AREA PLAN FOR TAR0003 WITH VALIDATION PROBES

Prior to the second phase of treatment, validation probes (VP406, VP407, VP408 and VP409) were undertaken adjacent to No. 7 Highbarns to investigate the presence of mining disturbed ground beneath the driveway as well as the potential extent of mining disturbed ground extending towards No. 9 Highbarns. Results showed competent ground and did not indicate the presence of mined ground. Additional rows (VP420, VP421 and VP422) and (VP466, VP467 and VP468) were undertaken which also showed competent ground with no indication of mine ground at the boundary between No. 7 and No. 9 Highbarns. However, during drilling of CGV176 within No. 9 Highbarns, a void was identified between depths of 19.5m and 21.5m bgl. This is explained in more detail in the following section. Two internal validation probes (VP455 and VP127) were undertaken to 9.8m and 18.5m bgl inside the building. Results showed competent ground with no indication of mined ground.

Validation probes carried out following treatment works were undertaken to depths of between 16.5m and 19.9m bgl did not record any weak ground that would be indicative of untreated mining.

A row of validation probes (VP420, VP421 & VP422) were undertaken in response to the identification of a void between depths of 19.5m and 21.5m bgl during drilling of CGV176 located on the boundary of No. 7 and No. 9 Highbarns. Results of this validation probing indicated competent ground to 21.7m bgl. However it was considered prudent to grout this area and a grout volume of 4.264m³ was injected into CGV601.

A row of validation probes (VP423, VP424, VP425 and VP426) located in the driveway of No. 15 Highbarns were undertaken to depths ranging between 15.5m and 16.8m bgl. Results of the validation testing did not indicate residual untreated mined ground and confirmed the termination of the southeast-northwest trending mine passage within the DLCO boundary.
